MISMANAGEMENT OF MEDICAL CONDITION ON BOARD

A TRAGIC INCIDENT UNFOLDED ON BOARD A BULK CARRIER, CLAIMING THE LIFE OF A CADET WHO HAD SPENT THREE MONTHS ON BOARD. THE 34-YEAR-OLD TRAGICALLY LOST HIS LIFE AFTER INHALING HYDROCARBON FUMES EMITTED FROM A BUNKER TANK VENT WHILE THE TANKS WERE BEING HEATED. THE SHIP'S MANAGEMENT TEAM INITIALLY MISJUDGED THE SEVERITY OF THE CADET'S ILLNESS, LEADING TO A CRITICAL DELAY IN PROVIDING THE NECESSARY MEDICAL TREATMENT AND ADVICE.

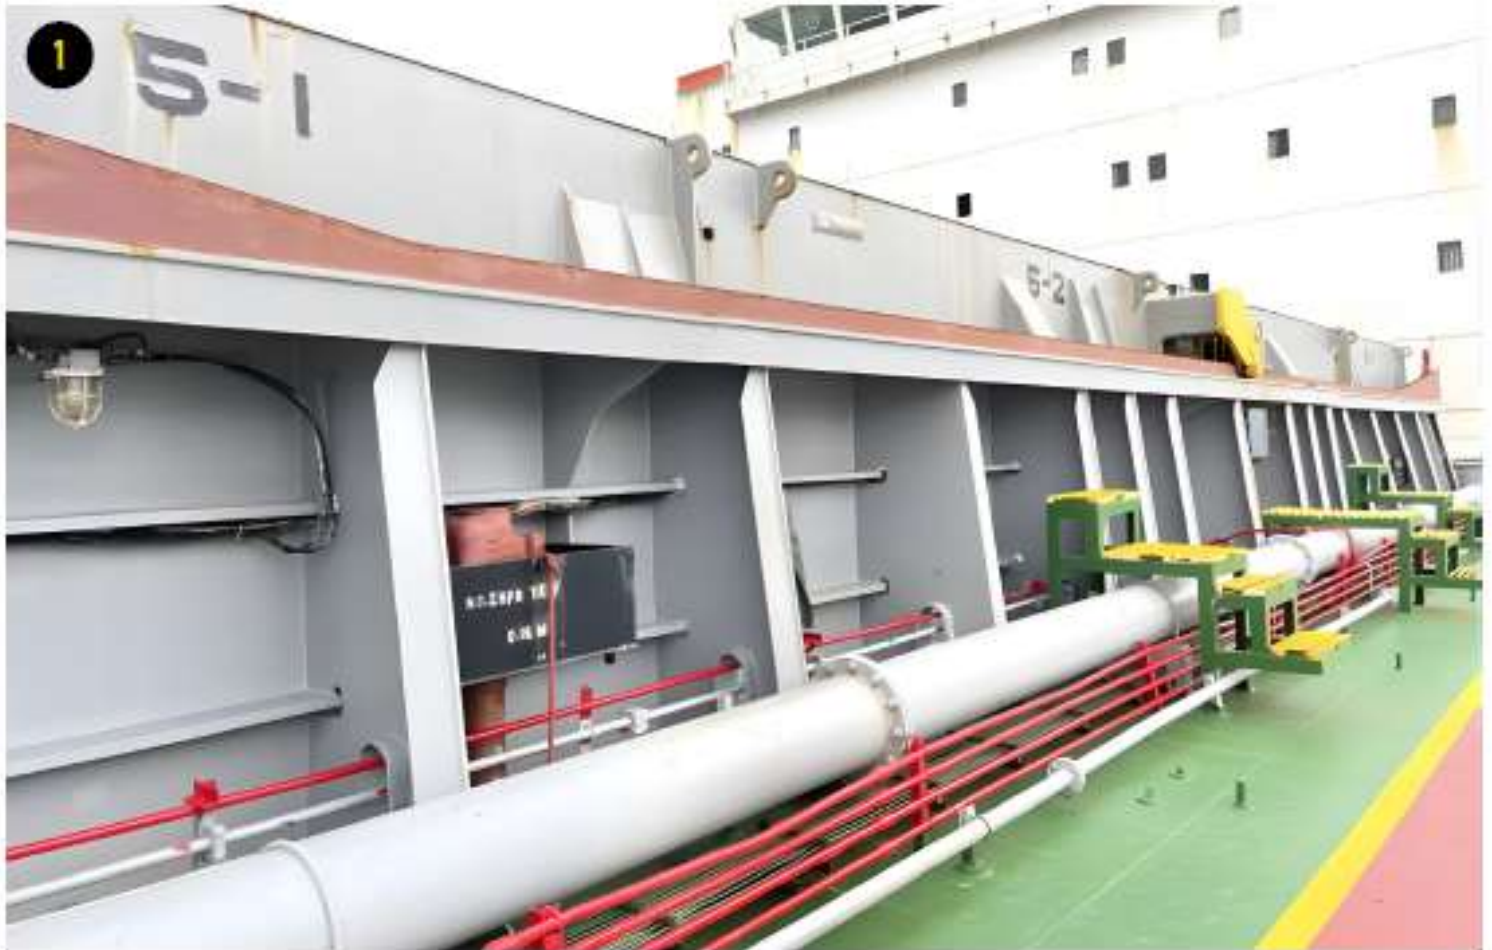
On 12 November 2022, aboard a bulk carrier off the western coast of Africa, a sequence of events unfolded that tragically led to the death of the deck cadet (DC). At the time of the incident, the ship was carrying approximately 46,000 MT of Nickel Ore, with the no. 5 cargo hold loaded to an estimated 47%. The ship had several Heavy Fuel Oil (HFO) tanks, including the no. 2 HFO tank (port), which emitted vapours from vents with approximately 170 MT low Sulphur fuel (0.49% of Sulphur content). The ship's chief officer (CO) tasked the fitter with conducting repairs in the no. 5 cargo hold, and both began preparations around 0800 hours. They noticed a strong smell of fumes emanating from a vent associated with the no. 2 HFO tank port.

FIGURE 1 VIEW OF THE FORWARD VENT FOR NO.2 HFO TANK (PORT)
SOURCE MARINE SAFETY INVESTIGATION REPORT - TSIB - MOT - SINGAPORE

The fitter was tasked by the chief officer to carry out some repair work inside no.5 cargo hold and the fitter prepared the items needed for the repair with the DC. When the bosun opened the hatch cover, both the fitter and the DC were waiting near no. 2 HFO tank port and noticed a strong smell of fumes from the vent of HFO tank. The DC lowered equipment required for repair into the hold standing on the raised steps aft of the HFO tank vent.
