## IMCA Safety Flash 24/16

September 2016

### Focus: Fire

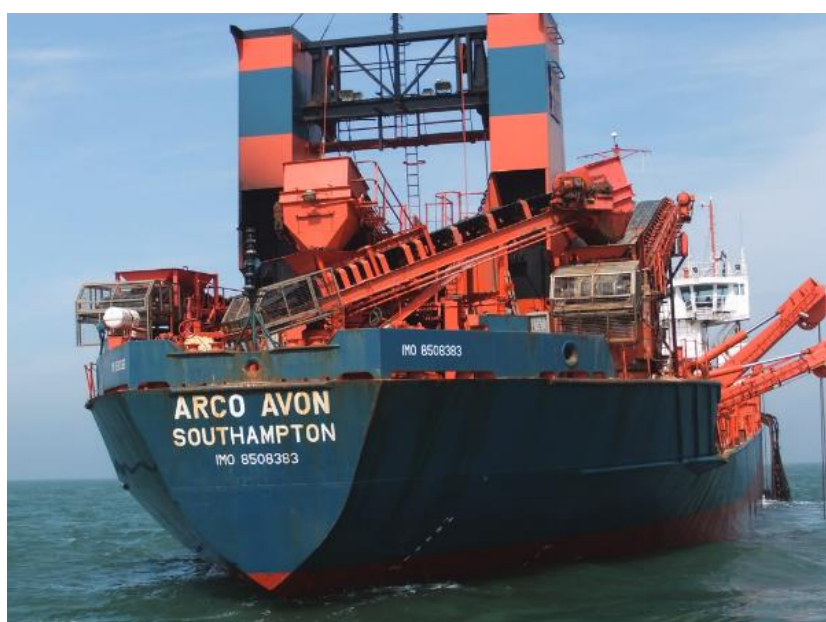
A fire broke out in the engine room while the vessel was loading a sand cargo approximately 12 miles offshore. The vessel's third engineer was badly burned in the fire and later died as a result of his injuries. As a consequence of the fire, which was extinguished following activation of the CO<sub>2</sub> smothering system, the vessel lost all power and remained at anchor with its dredging equipment partially deployed for 9 days until it could be taken under tow and delivered to a repair facility.

- ♦ The third engineer was attempting to repair a failed fuel pipe when fuel, under pressure in the pipe, ignited;
- ♦ No one else on board was aware of a failed fuel pipe or that the third engineer had apparently decided to repair it;
- ♦ The third engineer was using a portable angle grinder to access the repair site and had underestimated the risk of doing so;
- ♦ Possible contributing factors to the third engineer's underestimation of risk were that he had neither carried out a formal risk assessment nor sought a permit to work before starting the repair.

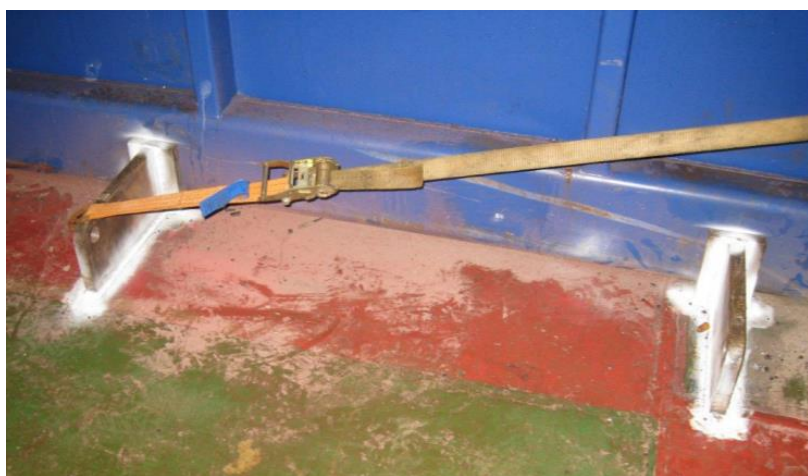
A member has reported a near miss incident in which welding was discovered which had clearly taken place in a 'no hot work' zone. The welding was discovered during pre-sail departure checks of the main deck. The Chief Officer noticed dogging plate welds securing a half-height container had been welded on to a 'no hot work' zone on the deck.

The above figure shows Welds on 'no hot-work' zones

Our members' initial finding was that the task was not properly planned or supervised, allowing sea-fastenings to be welded on to a 'no hot-work' zone.

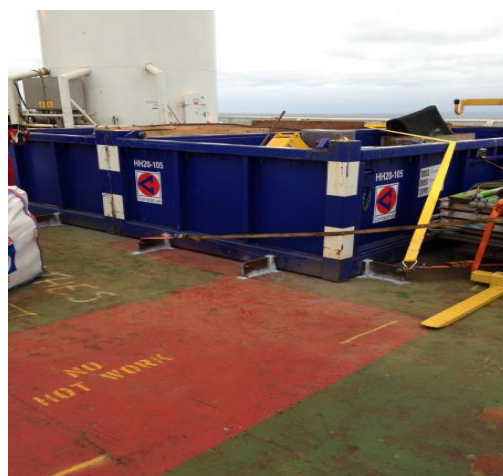
Clearly identified RED 'no hot-work' zones

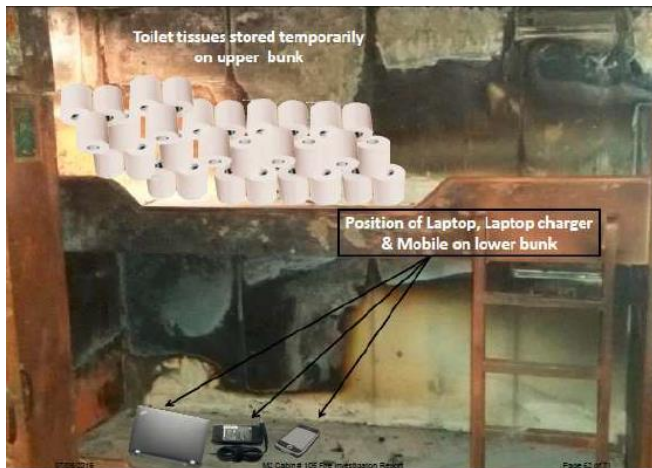
*Location of fire*

- ♦ The occupant of the cabin had borrowed the notebook computer and was not an experienced computer user;
- ♦ The notebook computer had been fully charged when he turned it on so he didn't plug it in to charge it;
- ♦ It appears that the notebook computer was inadvertently turned on whilst laying on a bunk bed, and this reduced the efficiency of the cooling fan which caused the computer to overheat;
- ♦ The integrity of the scene, with regard to investigation, was necessarily compromised after the incident;
- ♦ The remains of the notebook computer were at the heart of the fire, but had been rendered almost totally unrecognisable after being subjected to the fire and the water spray – distinctly heavy burning to the mattress and the wood underneath was evident at the notebook computer location;

- ♦ The remains of the computer along with other debris were scraped up, removed and subject to further water cooling to prevent the possibility of re-ignition;
- ♦ The bunk curtain also caught fire and this allowed the flames to track up onto the top bunk which was unoccupied. There were flammable items kept on the unoccupied bunk including toilet paper which also caught fire. The two bunks and mattresses were damaged, as were bunk curtains and adjacent wall and ceiling panels.

- ♦ Leaving the notebook computer lying on the bedding would have decreased the efficiency of the cooling fan and caused the notebook to overheat;
- ♦ The cabin was left unoccupied with electronic equipment inadvertently left powered on;
- ♦ Toilet rolls were left on the top bunk, this easily combustible material will have ignited and burnt very quickly.

- ♦ Checked of all cabins to ensure that there were no electrical/electronic items which might cause a similar incident;
- ♦ Safety flash was issued and Toolbox Talk was held to emphasise the dangers of leaving electrical items charging unattended. Also, stating that care should be taken to ensure that fans and cooling vents are not compromised on electrical equipment;

- ♦ Signs (stickers) to be posted next to all cabin sockets stating that *“No electrical items are to be left charging while unattended. Fans and cooling systems of Electrical Equipment not to be obstructed while in use or charging”*;

- ♦ Vessel inductions to be revised to include electrical safety – a do’s and don’ts list will be developed;
- ♦ Personal electrical equipment used in cabins will need to be inspected and approved by the electrical technical officer (ETO);

- ♦ ETO to conduct regular unannounced inspections to ensure that there are no electrical hazards present in the cabins;
- ♦ Extension cables and sockets to have surge protection and some form of overload or ground fault protection such as an RCD.
